Flanders is hermetically sealed

Paved surfaces in Flemish municipalities

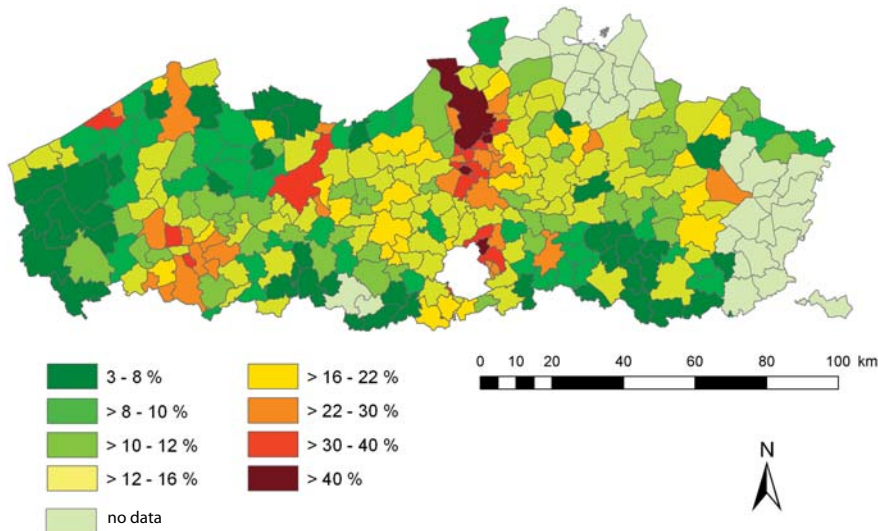
186 000 ha or 13.8 % of the Flemish soil is sealed. There are still a few areas in Flanders where there are municipalities that have a sealing percentage lower than 8 %, especially in the Westhoek, South Limburg and Meetjesland. In municipalities located in the Flemish Diamond (Ghent, Antwerp, Leuven and Brussels) more than 12 % of the surface is sealed. The percentage of soil sealing along the coastline is relatively high as well, especially in comparison with the nearby Westhoek.
